Effect Of Polymicrobial Peri-Implant Plaque On The Morphological Degradation And Titanium Ion Leaching Of The Zimmer Biomet Osseotite Implant

Abstract

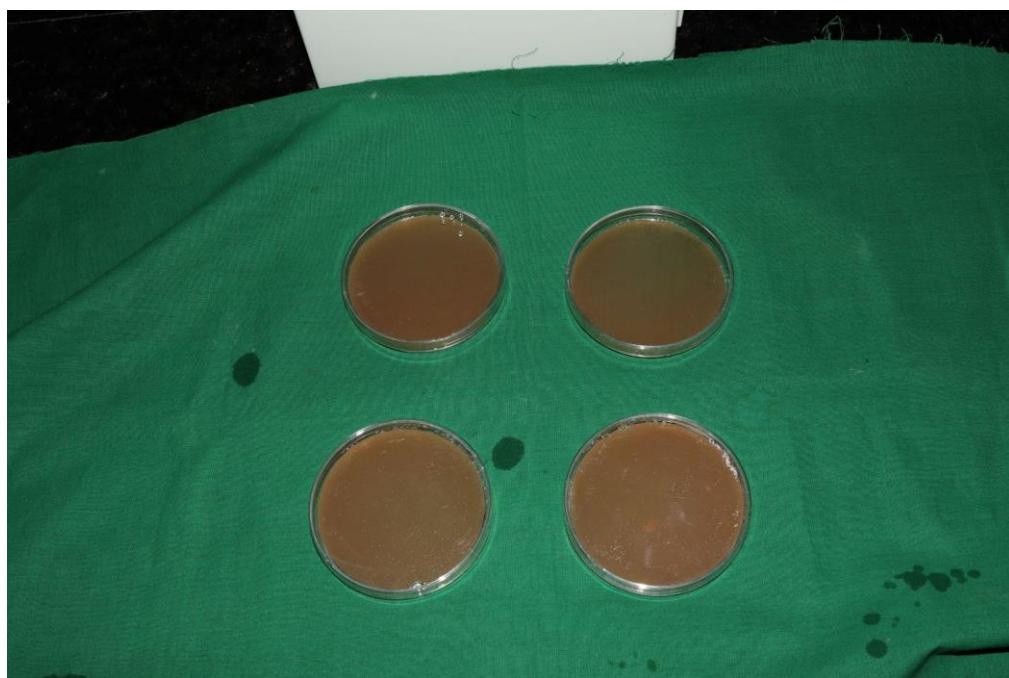
Figure-1 showing magnesium oxidising media

Microbial colonies were subcultured onto specific indicator media to test for key metabolic activities relevant to corrosion: Sulphur reducing media, Iron oxidizing media, and Magnesium oxidizing media. Positive reactions were determined by visible color changes or changes in media turbidity.

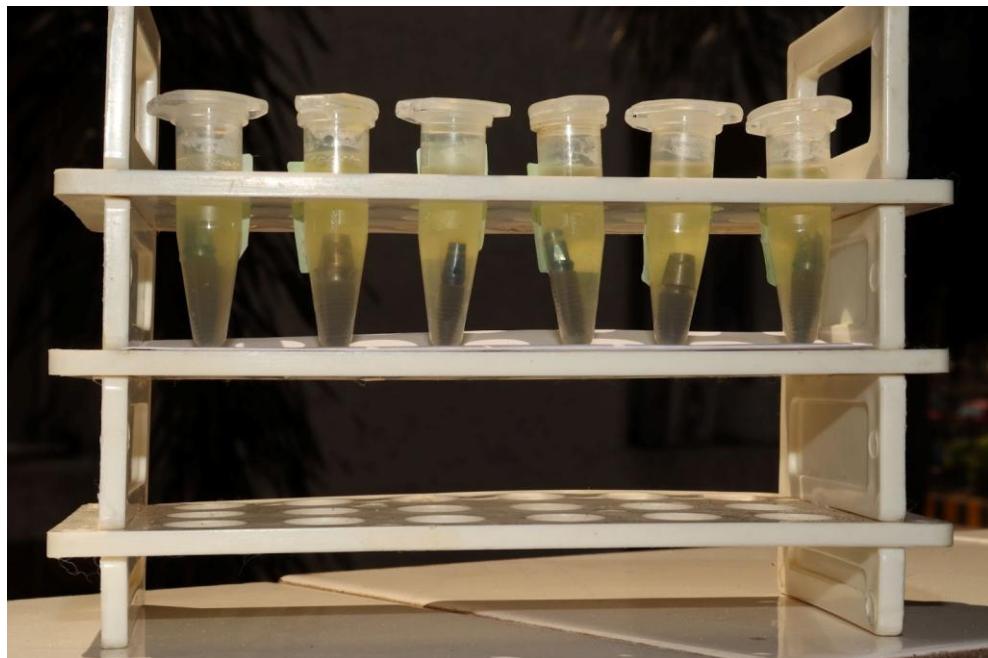
Figure-2 showing the implant incubated in the broth

Aliquots (1 ml) of Thioglycollate broth were taken in 1.5 ml Eppendorf tubes. From each of the 10 patients, a 100 μ L sample of plaque was micropipetted into a separate Eppendorf tube. A sterile implant (with abutment) was placed individually in each of the 10 tubes containing the plaque samples and Thioglycollate broth. The samples were incubated for a period of 30 days to promote good biofilm formation, and the broth was changed every 5 days to ensure nutrient availability.
